Manhole Inspection Summary

Manhole # S2111_018MH

Location Address: **2908 hollins ferry rd**

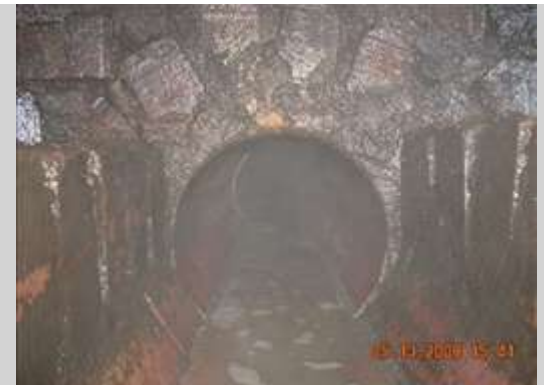
6 O'Clock Inflow

8 in. Circular Gravity Sewer
Pipe In @ 6 O'Clock

Pipe Height: **8.4** (in.) Rod and Bar (Angled)
Pipe Material: **Clay** ☐ Pipe Lined
Invert Depth: **8.79** (ft.) Flow Characteristics: **Slow**
Deposits: ☒ **None** ☐ Mud ☐ Sludge ☐ Debris ☐ Grease
Silt Depth: **0** (in.) Deposits Extent:
Infiltration: **None** Pipe Seal Cond: **Unknown**

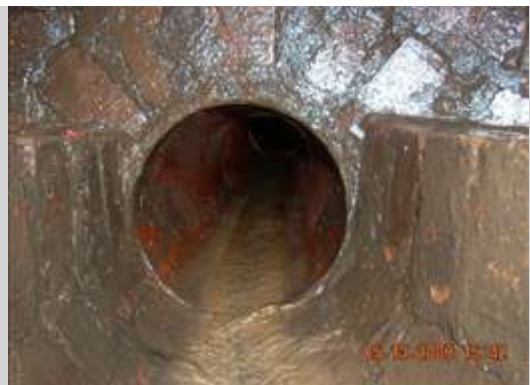
9 O'Clock Inflow

8 in. Circular Gravity Sewer
Pipe In @ 9 O'Clock

Pipe Height: **8.4** (in.) Rod and Bar (Angled)

Pipe Material: **Clay** ☐ Pipe Lined

Infiltration: **None** Pipe Seal Cond: **Sound**
